Re: Notice of Violation  
Compliance Evaluation Inspection  
EPA ID No.: IND 088 736 103

COMPLIANCE EVALUATION INSPECTION REPORT

**INSTALLATION NAME:** Honeywell Aerospace

**DATE OF INSPECTION:** April 14-16, 2015

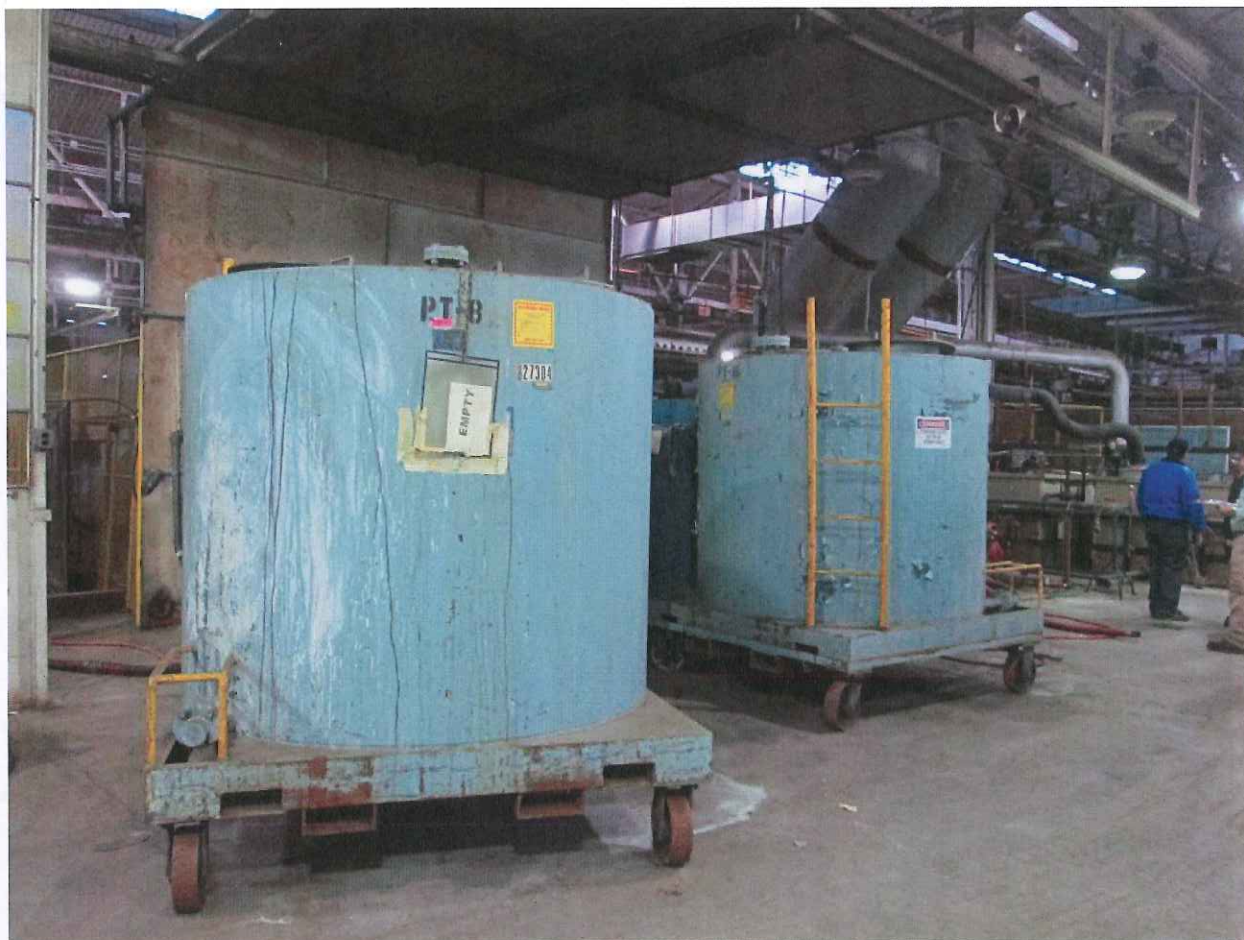
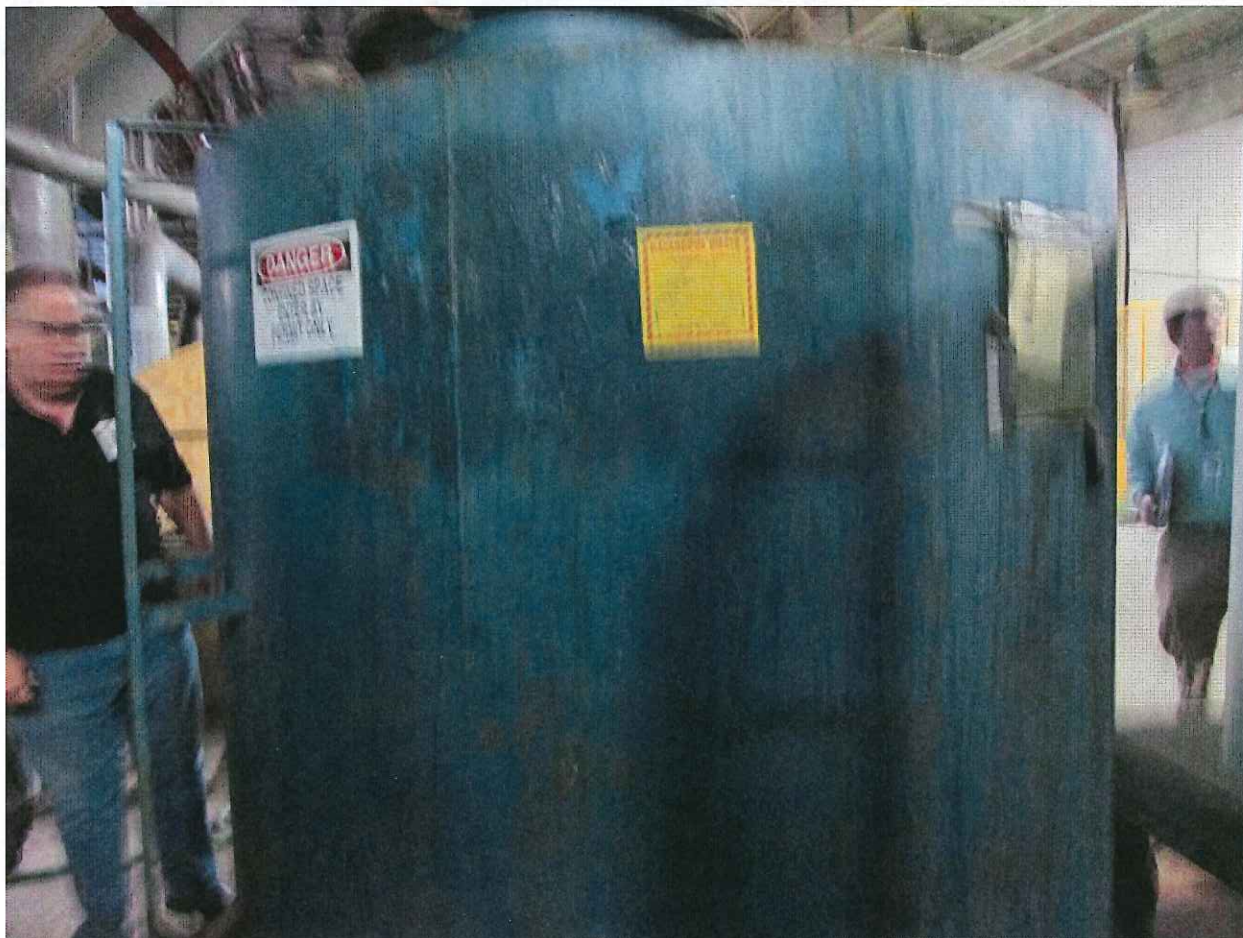
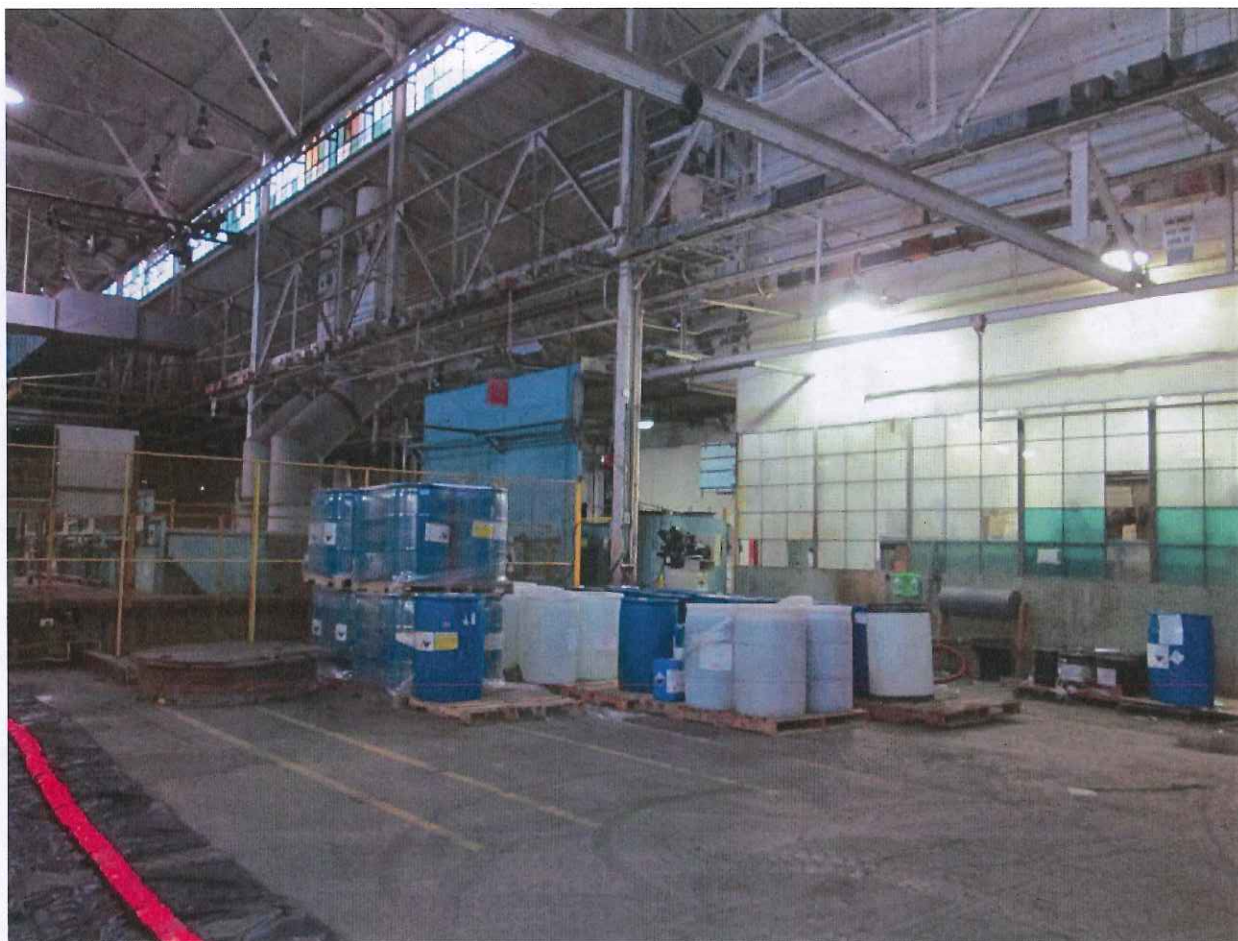
I returned to Honeywell to inspect Plant 11, chemical storage area after being informed by Paul Novak after the closing conference on April 15, 2015, about storage tanks in the chemical storage area. The chemical storage area used to be the wastewater treatment

plant before it was relocated to another area within the facility in May of 2012. There were three cleaned/emptied 1,000 gallon hazardous waste storage tanks in the area. Paul Novak looked inside the tanks to verify that they were indeed emptied. The tanks will remain on-site for possible reuse in the future (Photograph 58-60).

Emptied 1,000 gallon hazardous waste storage tanks

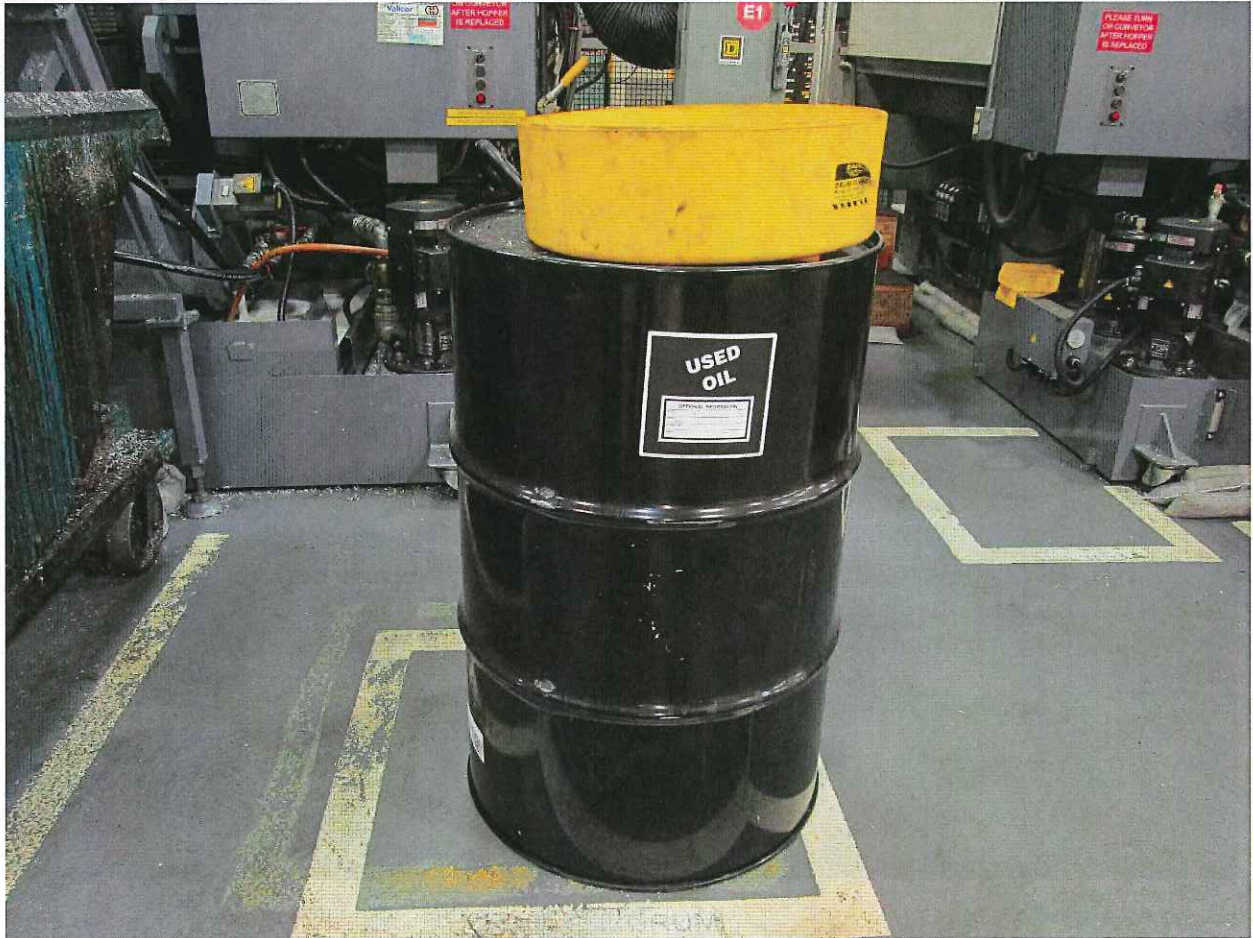
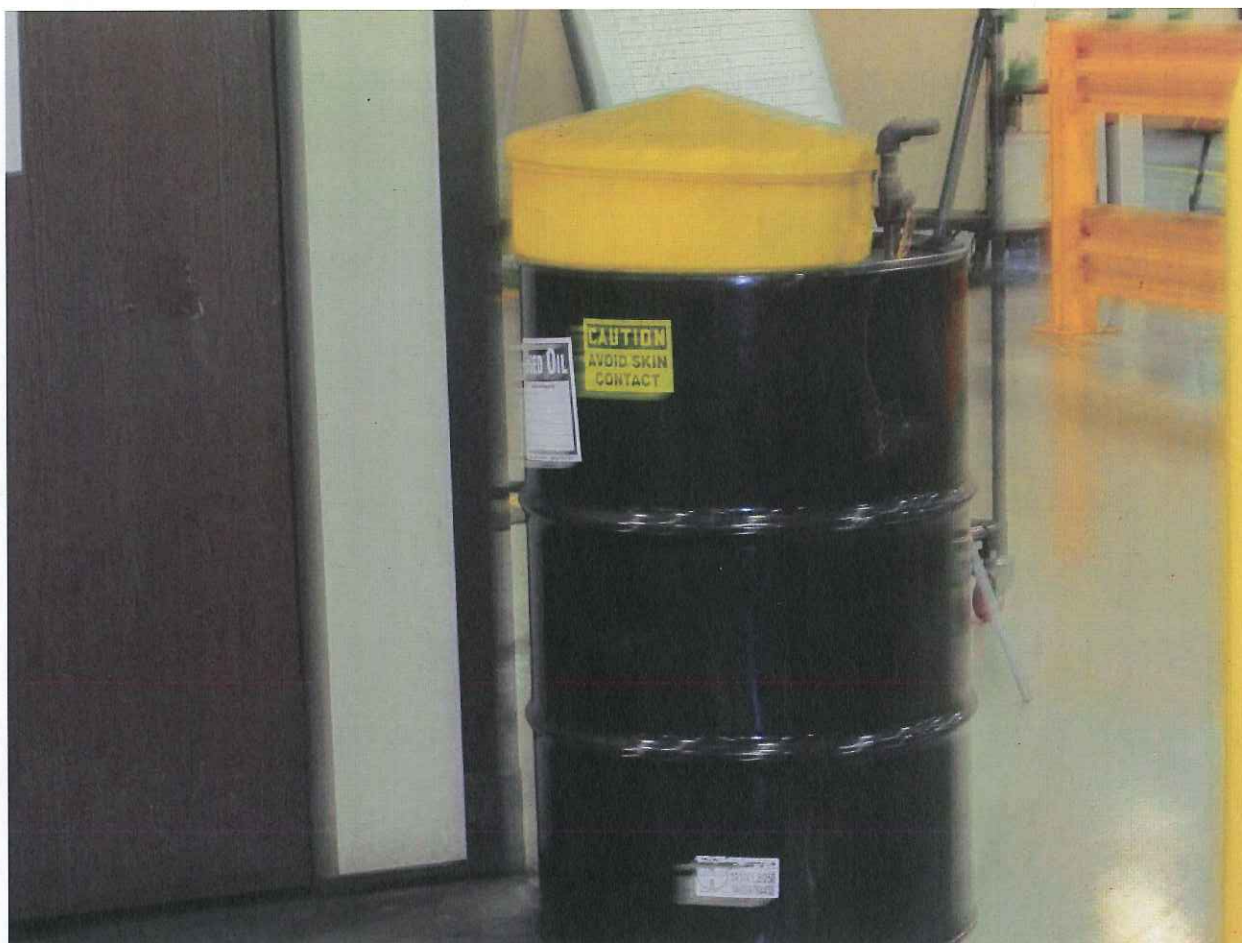
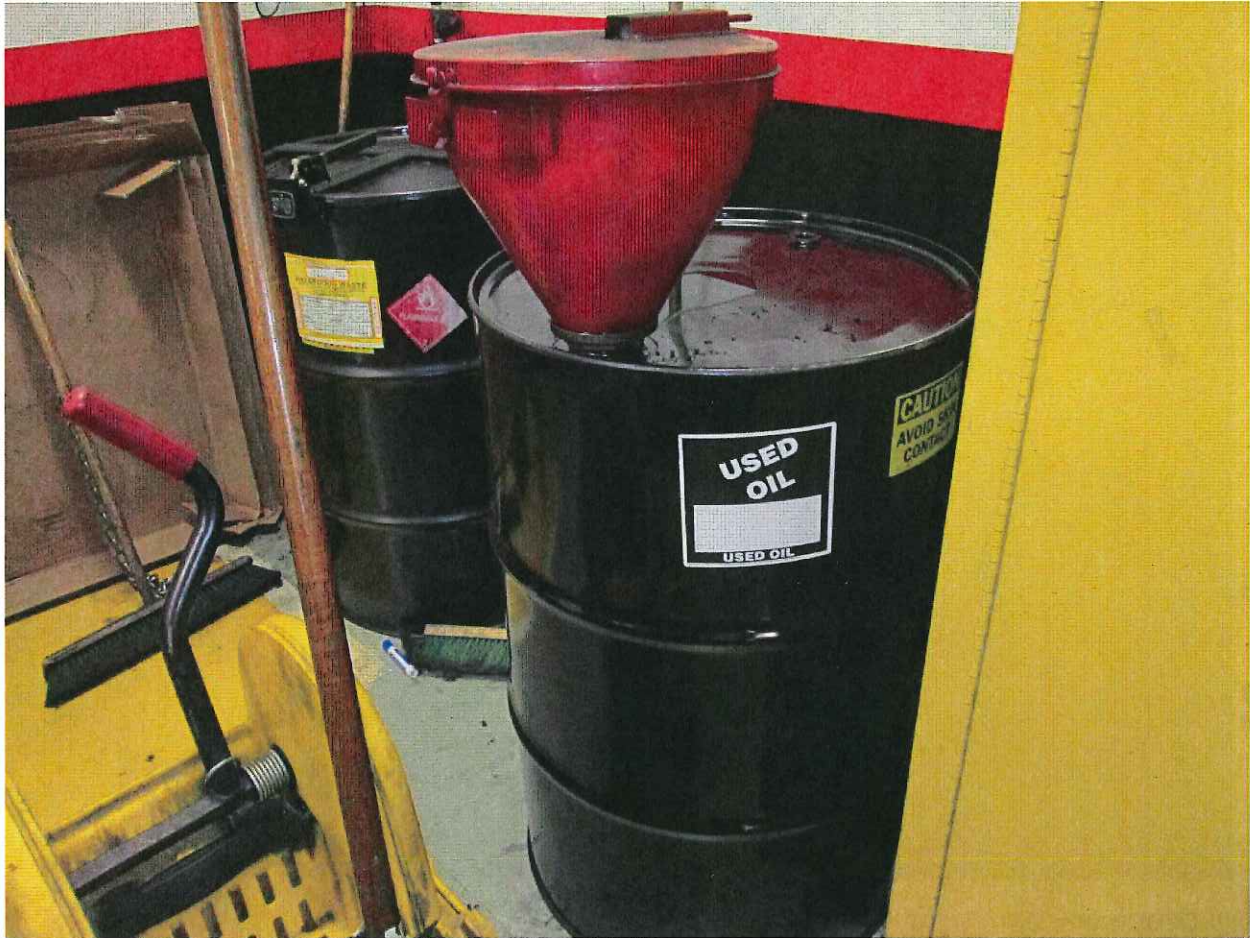
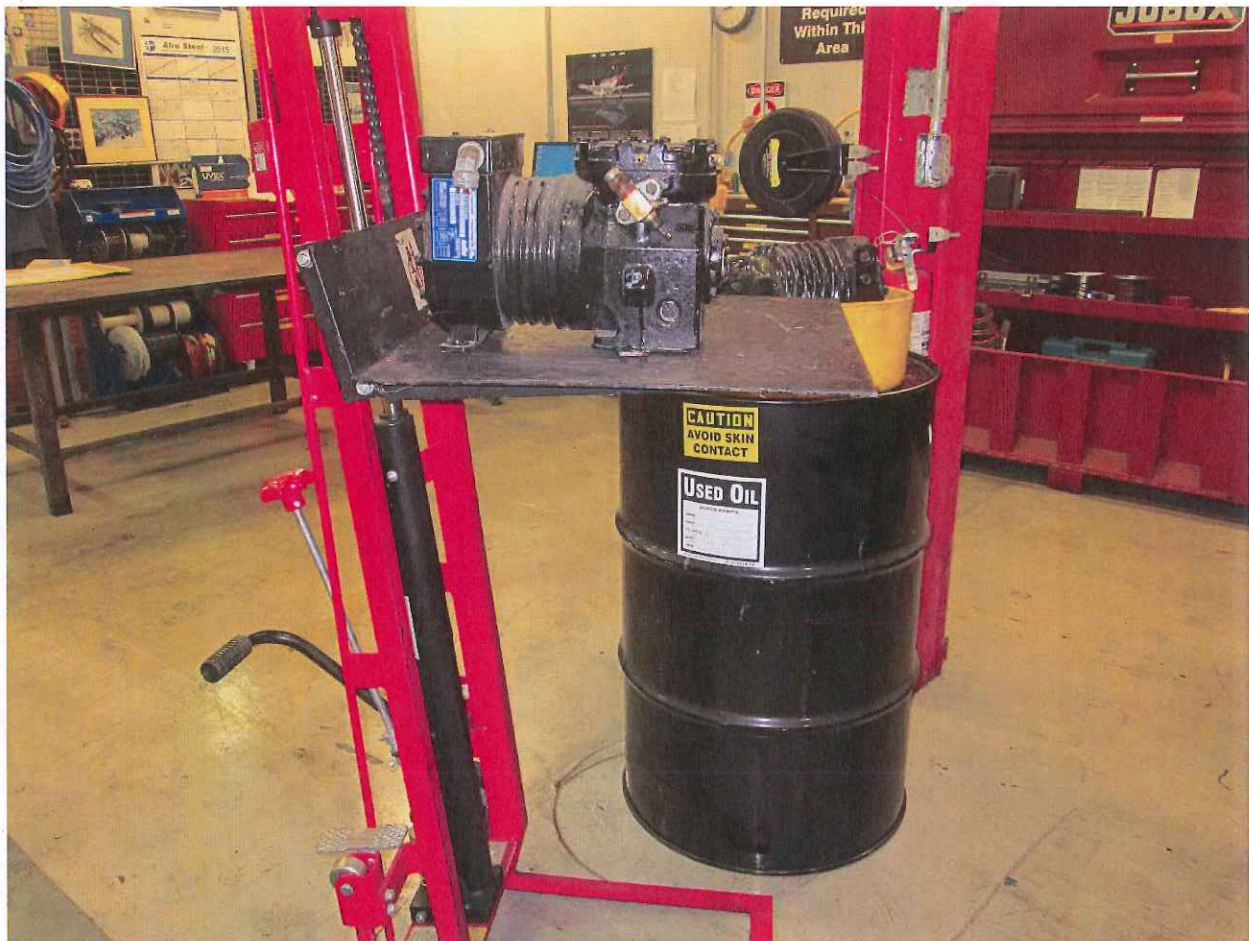
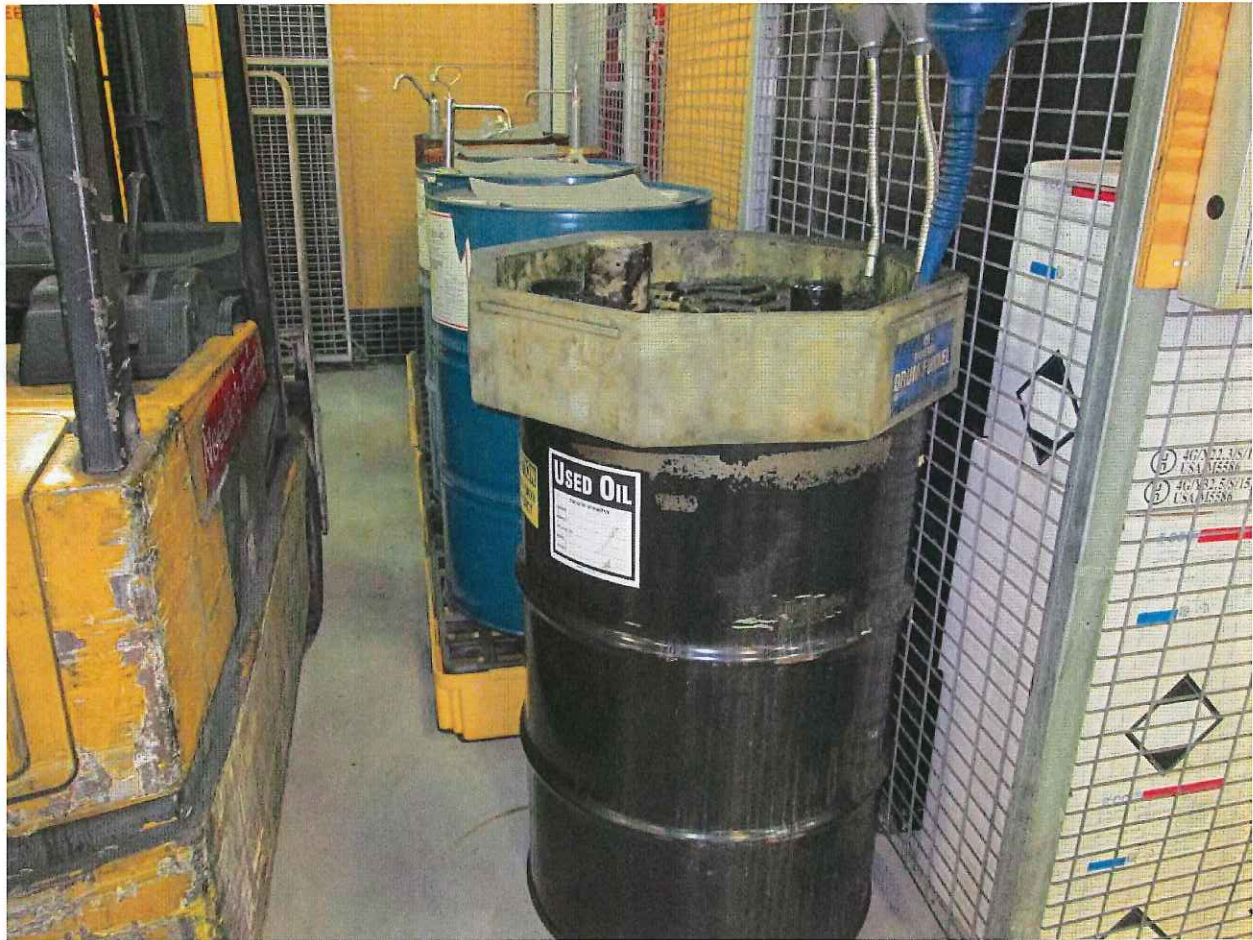
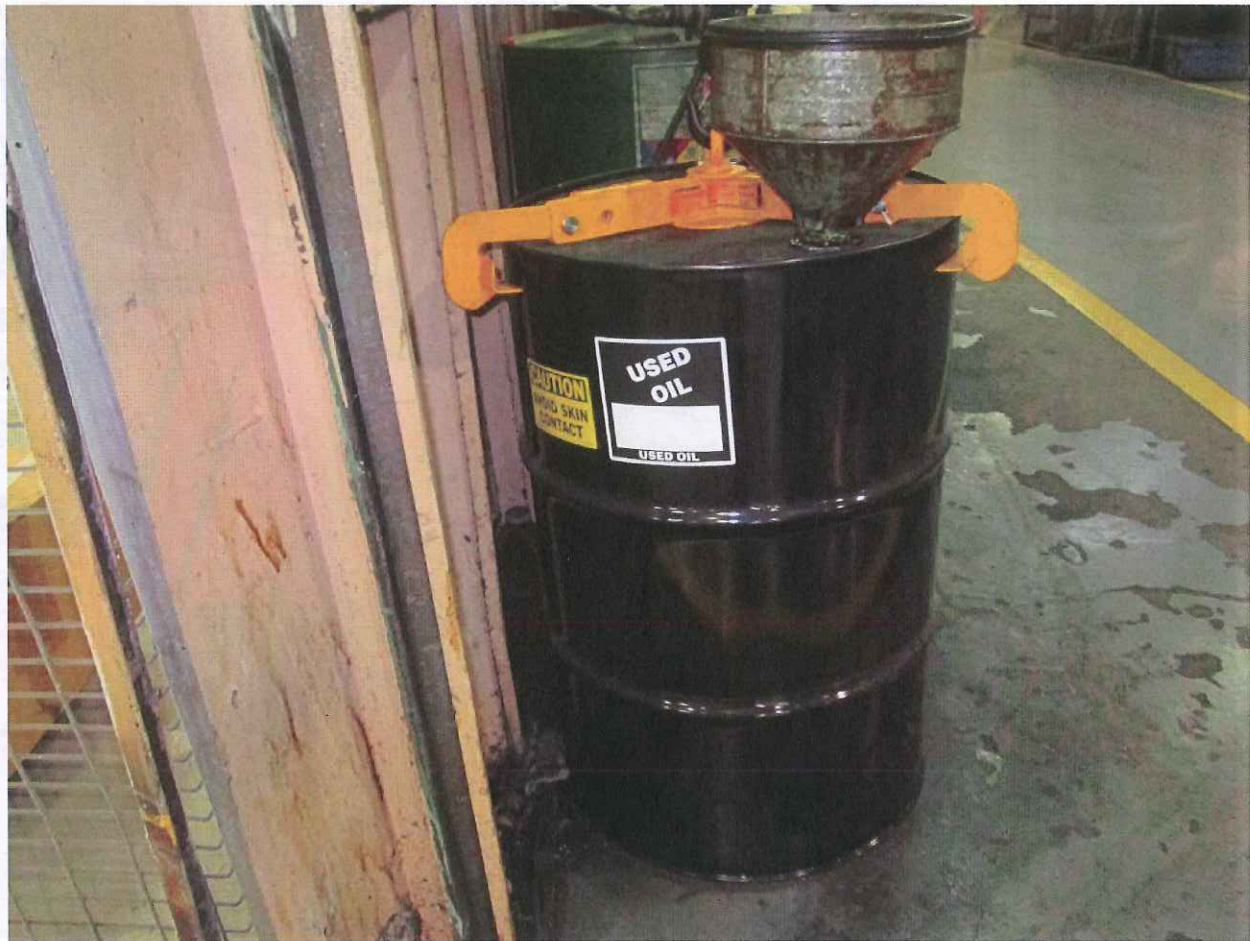
I observed labeled 55-gallon containers of used oil throughout the facility (Photographs 52-57).

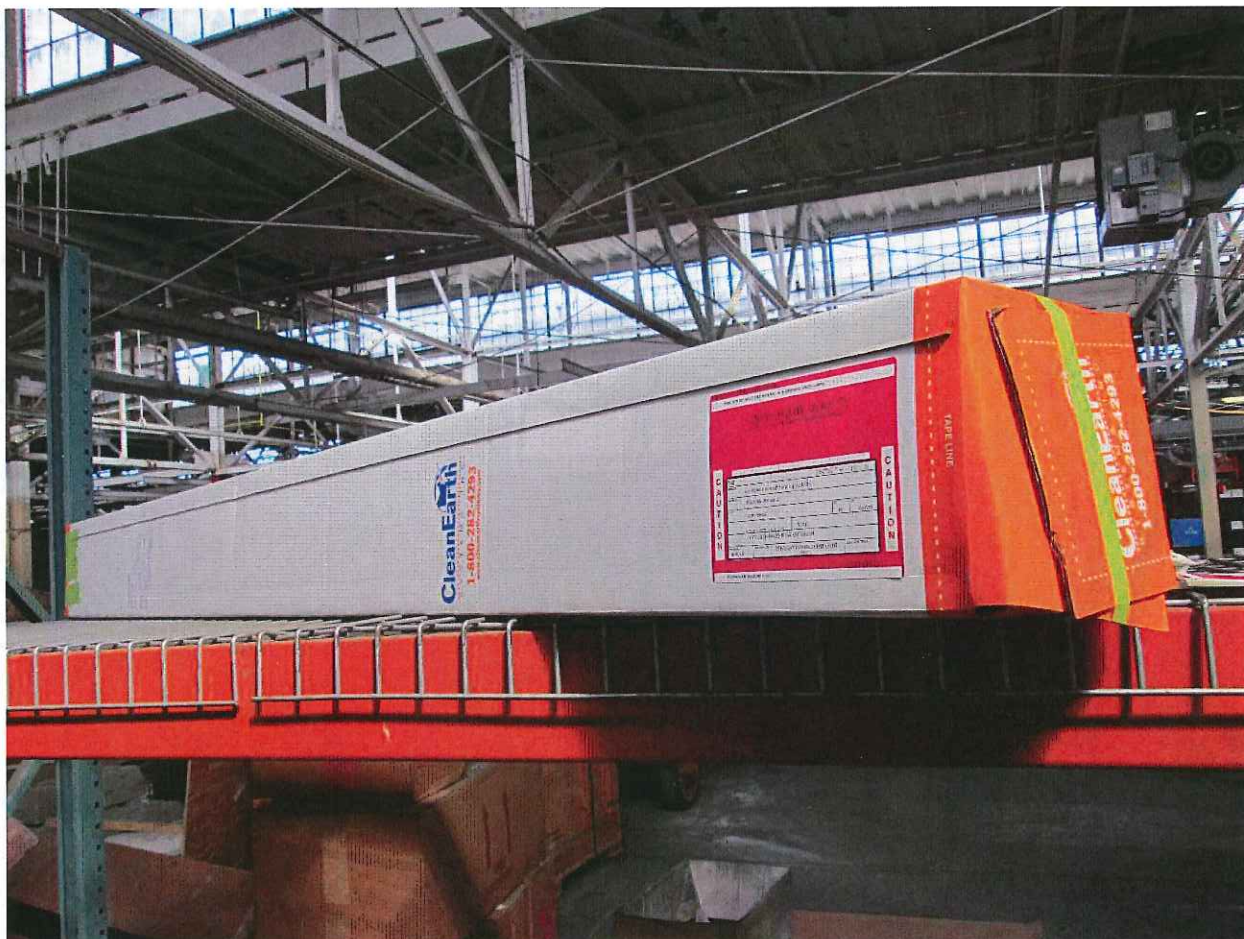
PHOTOGRAPH: 51

After leaving Plant 14, we proceeded to Plant 3 where there was a closed/labeled container of universal waste lamps (Photograph 51).

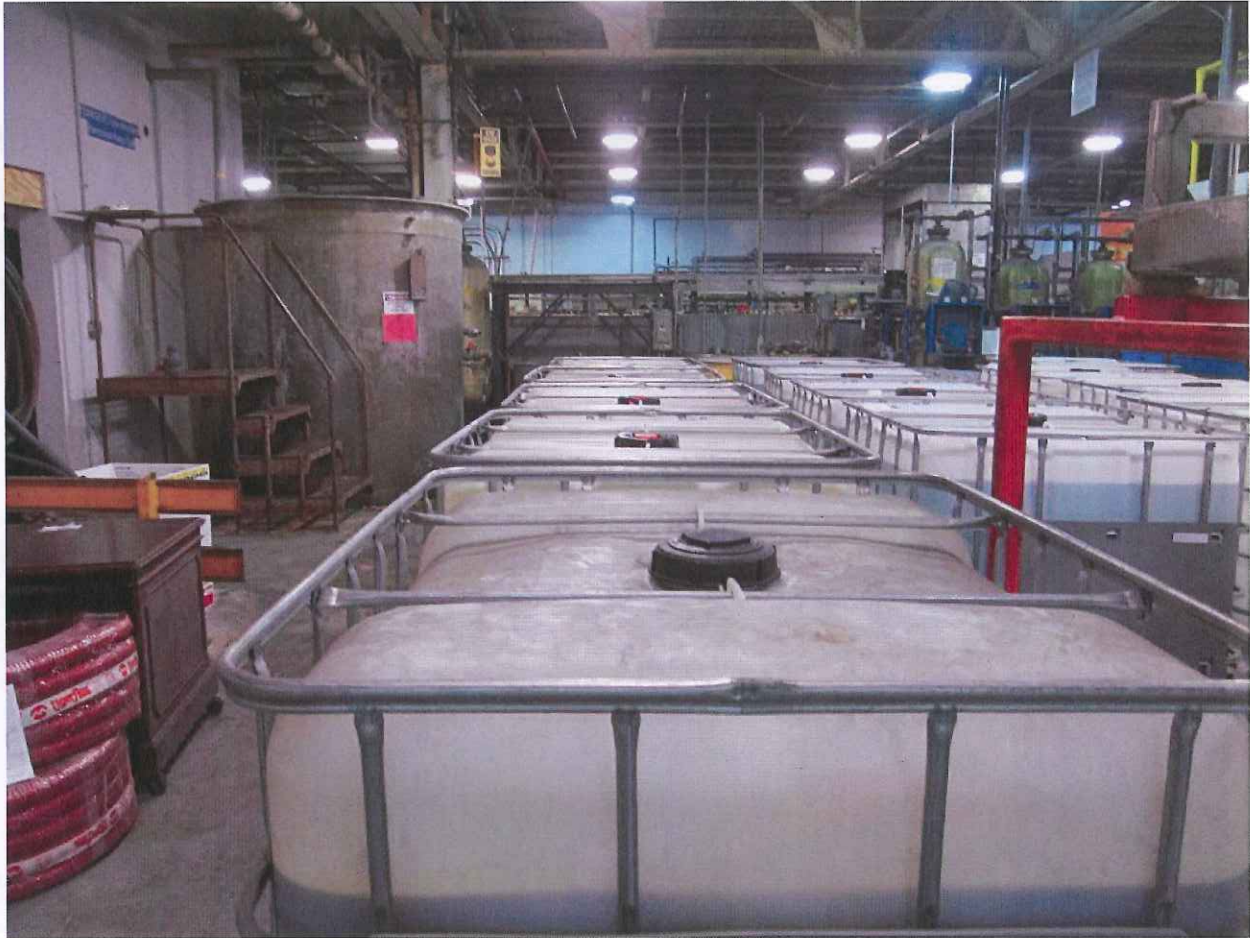
PHOTOGRAPH: 50

Next, we proceeded to the anodize line where there were five partially-filled 275-gallon containers of chromium sludge generated from tank clean-out (Photograph 50).

90-day Hazardous Waste...Anodize Line

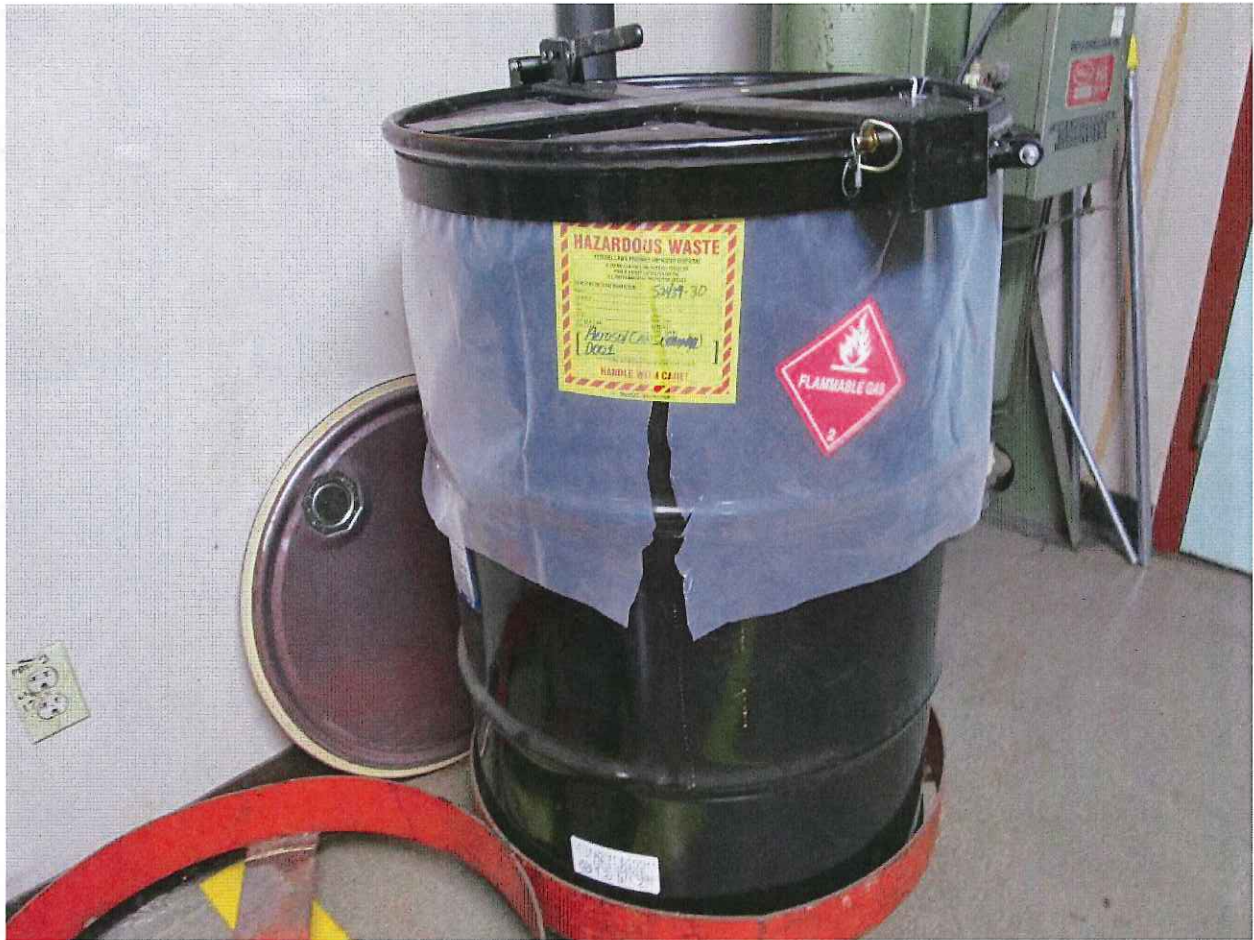
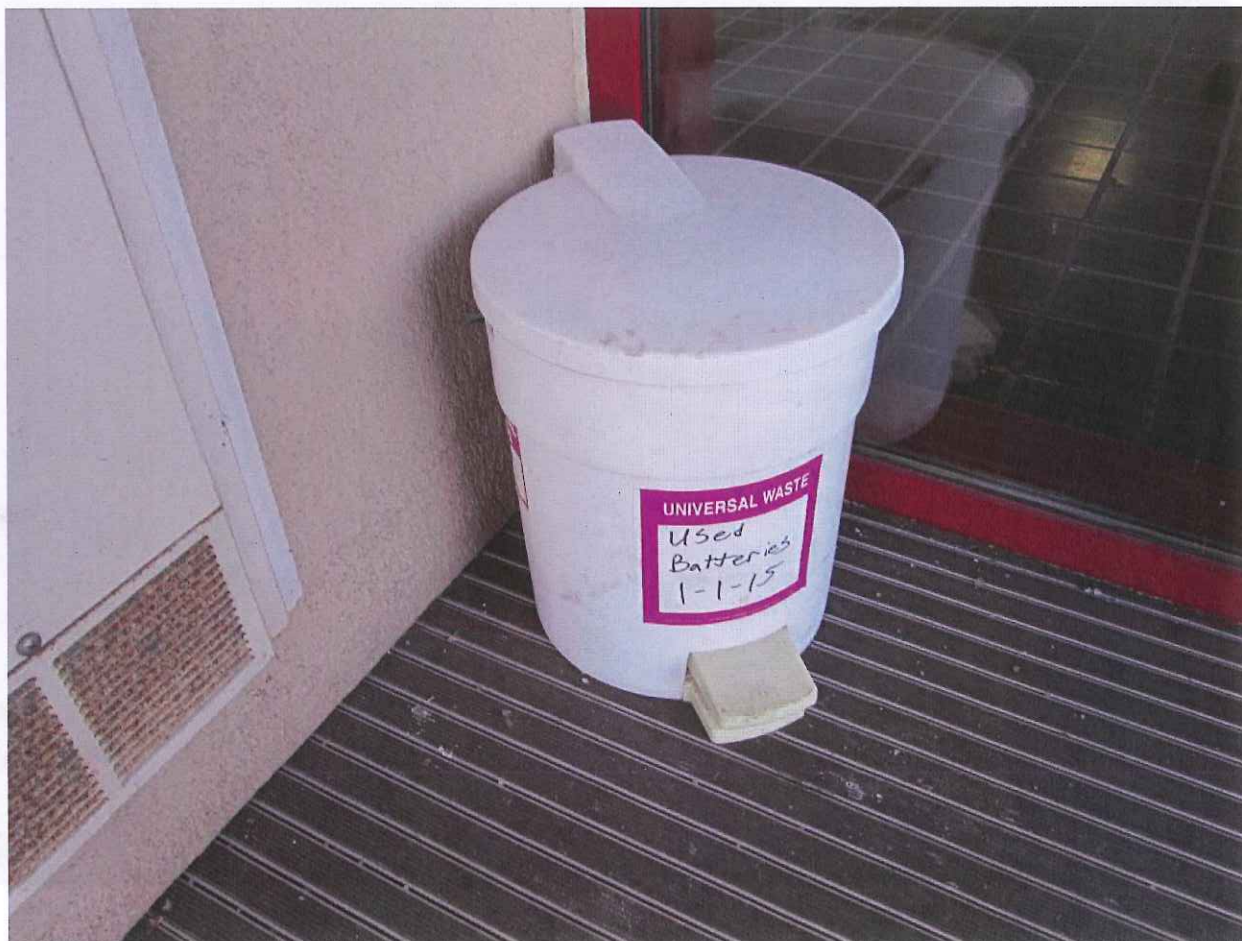
- There was one closed/labeled 5-gallon container of used batteries and one closed/labeled 55-gallon container of aerosol cans (Photographs 48-49).

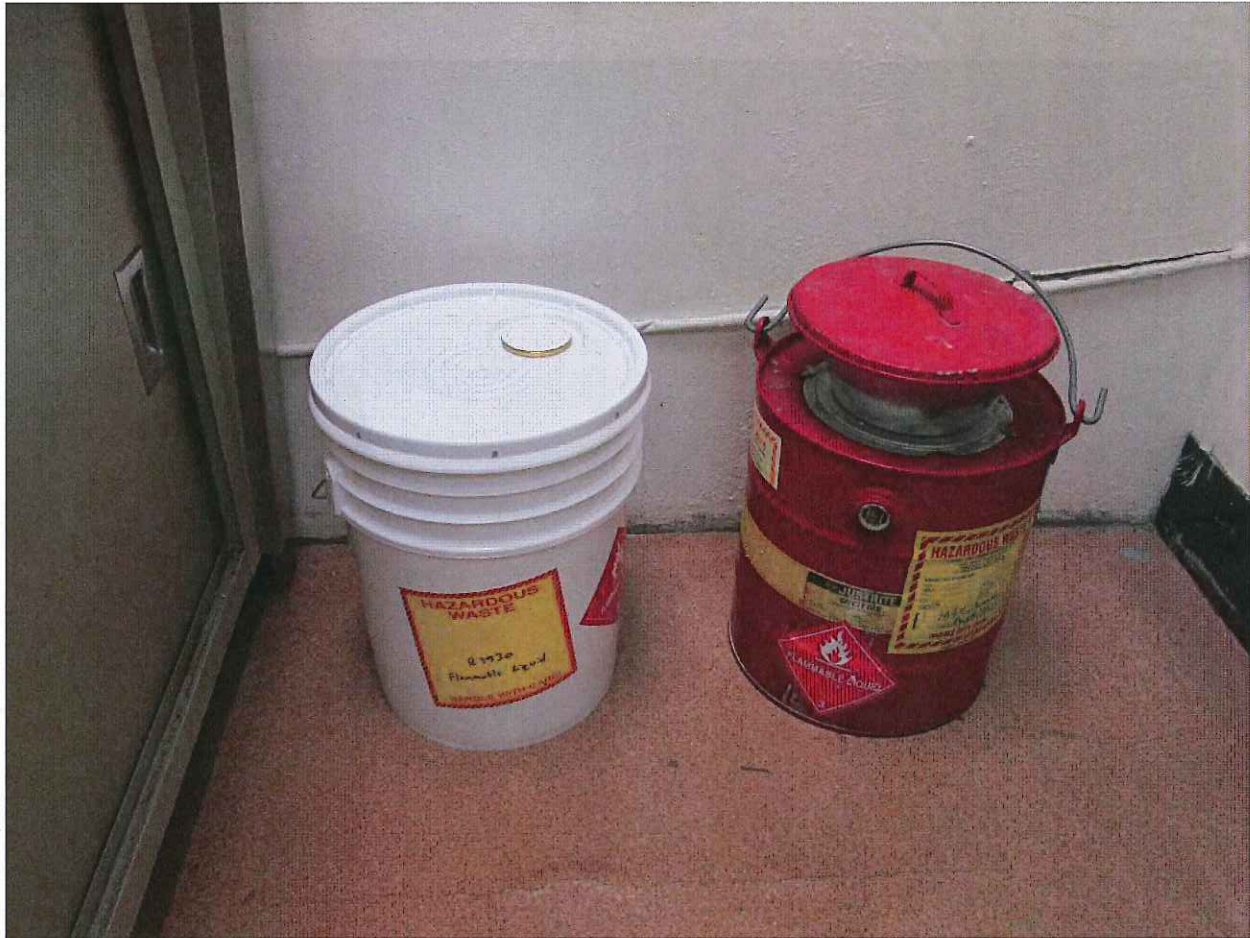
PHOTOGRAPH: 47

- There was one closed/labeled 5-gallon container of ferric chloride (Photograph 44).
- There was one unlabeled 30-gallon container of hazardous waste rags located in the print room. The container was labeled at the time of the inspection (Photographs 45-46).
- There was one closed/labeled 5-gallon container of MEK isopropyl acetone generated from dipping operations and one closed/labeled 5-gallon container of flammable liquid (acetone) generated from cleaning operation (circuit boards) (Photograph 47).

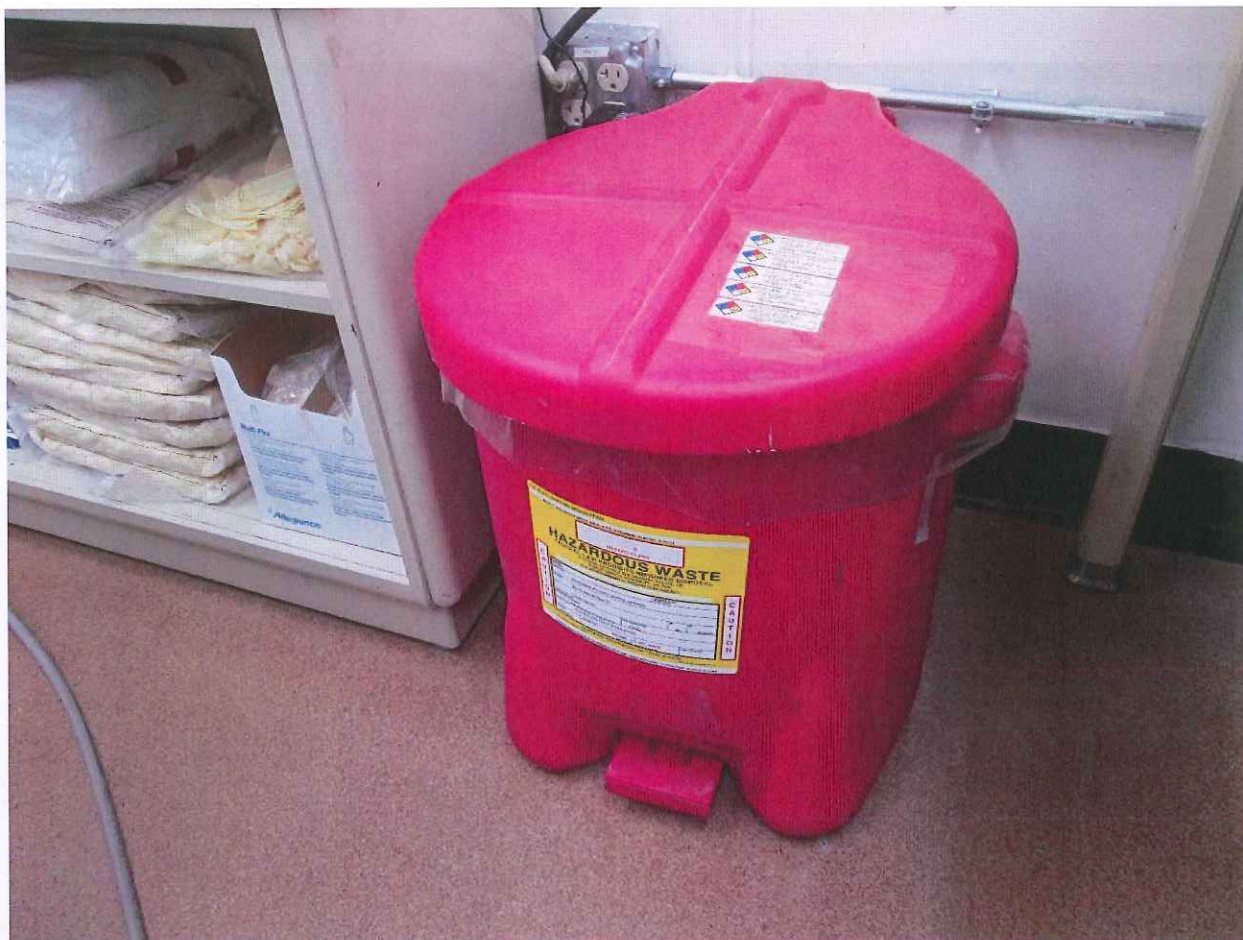
PHOTOGRAPH: 46

closed/labeled 30-gallon container of hazardous waste rags

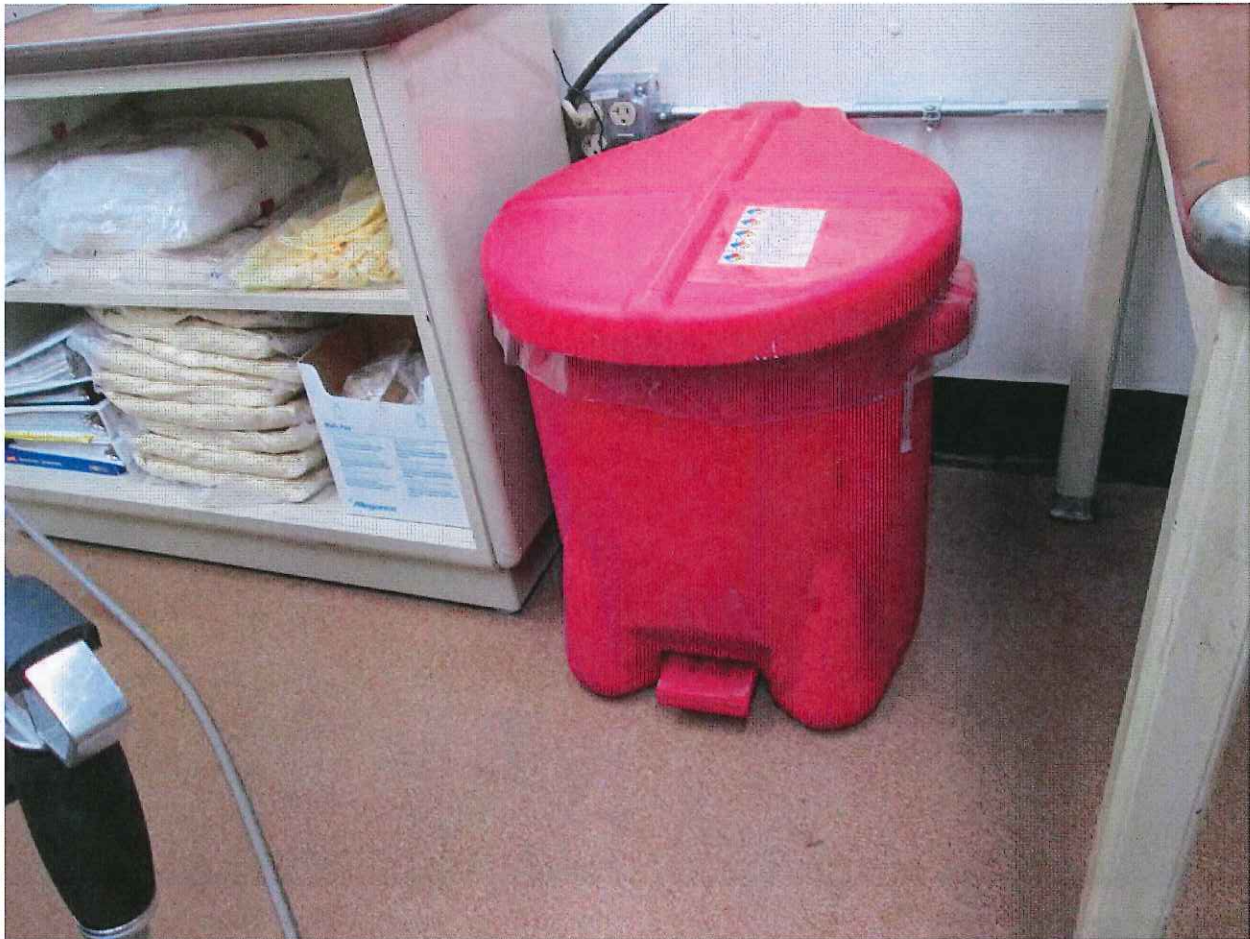
- one 30-gallon container of IPA waste located at the alcohol test stand;
- one 5.3-gallon of pain thinner waste and one 9-gallon container of waste rags, resin, used paint, etc. located at spray booth 1; and
- one 30-gallon container of hazardous waste rags located in the print room (Plant 35).

PHOTOGRAPH: 45  
NAME OF PHOTOGRAPHER: Sheila Burrus  
DATE OF PHOTOGRAPH: April 15, 2015  
LOCATION OF PHOTOGRAPH: Plant 14  
SCENE BEING PHOTOGRAPHED: unlabeled 30-gallon container of hazardous waste rags  
SITE LOCATION: 3520 Westmoor Street  
South Bend, Indiana  
INSTALLATION NAME: Honeywell Aerospace  
INSTALLATION I.D. #: IND 088 736 103
